MERG Report 2001-1

Research of Low Permeability Cover Performance at the Arctic Gold and Silver Mine Site, Carcross, Yukon

By EBA Engineering Consultants Ltd.

July 2001

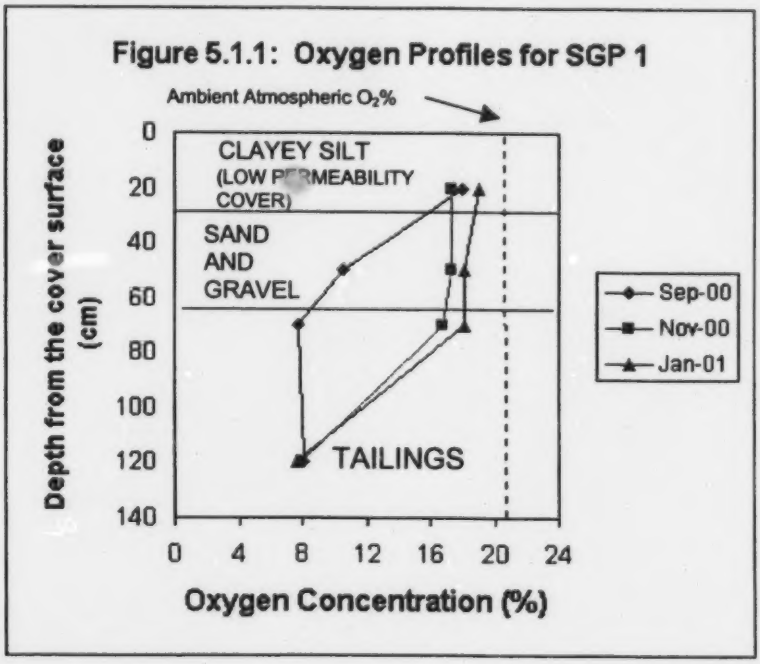
Figure 5.1.1: Oxygen Profiles for SGP 1

The trends that can be observed based on the oxygen profile graph are the following:

- During each monitoring event, there is less oxygen by % volume within the cover material than in ambient air. The clayey silt cover material had approximately 18% by volume of oxygen at a depth of 20 cm. This suggests that there is some limitation of oxygen flux between the atmosphere, and the tailings.

- Although there is consistency of oxygen levels with the clayey silt, and tailings over the three monitoring events, there is a temporal variability in oxygen levels within the sand and gravel and upper tailings. This could be explained by factors such as groundwater table fluctuations, seasonal frost variations, temperature effects on *T.Ferooxidan* activity, and barometric pumping, which would affect the oxygen concentrations in the sand and gravel due to the higher porosity within this layer.

At both SGP locations, it has been observed that there is a notable oxygen reduction with depth into the tailings. This suggests that there is some oxidation occurring within the tailings, or that decomposition of the organic silts and peats that underlie the tailings is

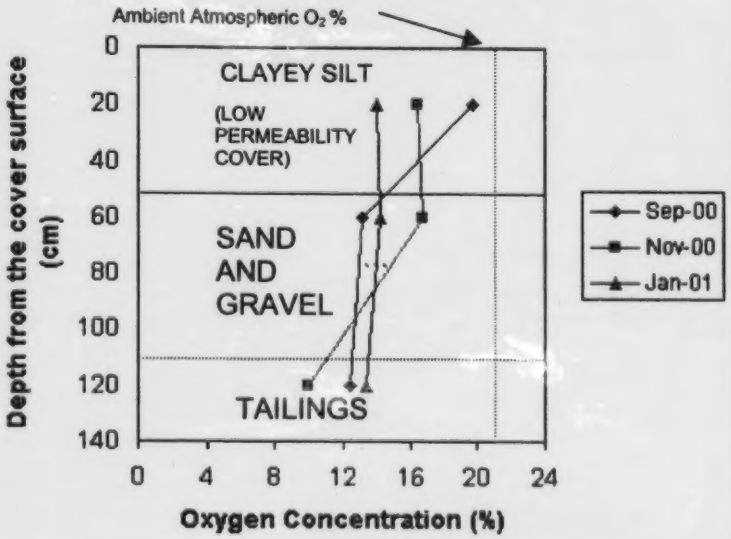
Figure 5.1.2: Oxygen Profiles for SGP 2

The trends that can be observed based on the oxygen profile graph are the following:

- There were some temporal variations in the oxygen levels observed within the low permeability cover material at 20 cm below grade over the monitoring period. Oxygen concentrations ranged from 13 % to 19 % by volume, however they were consistently below the ambient oxygen concentrations (20.9%) suggesting that the cover material was limiting the flux of ambient air into the tailings impoundment.

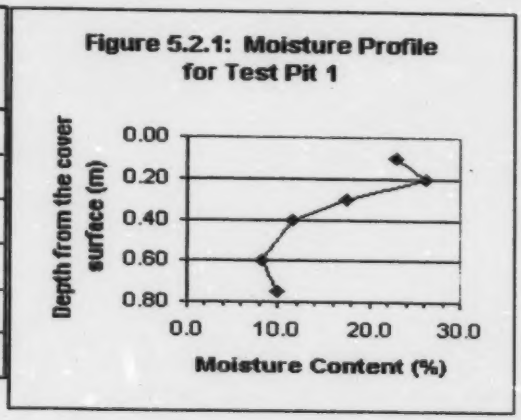
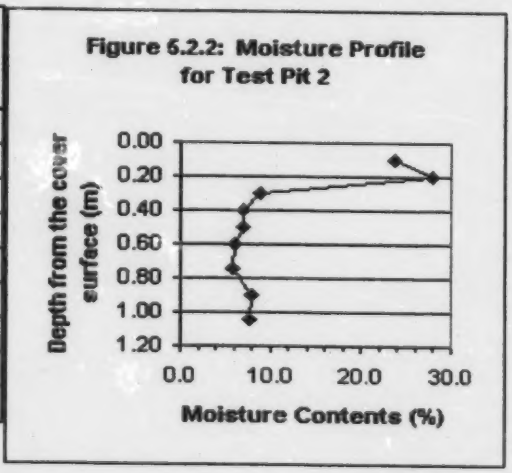
As can be observed from the tables and graphs presented above, the results of moisture content testing for each of the samples were very similar. The moisture contents started at approximately 23% at 0.10 cm and increased to approximately 27 % (full saturation) at 0.20 m within the cover material. Within the sand and gravel till below the cover, the moisture contents continued to decrease slowly. The hand-dug testpit at TP1 had refusal within the sand and gravel till on a cobble, and hence was not advanced into the tailings. TP 2, however was advanced into the tailings, where the moisture content increased slightly. Based on the moisture content results, it appears that the cover material is working effectively to limit moisture migration into the tailings impoundment.

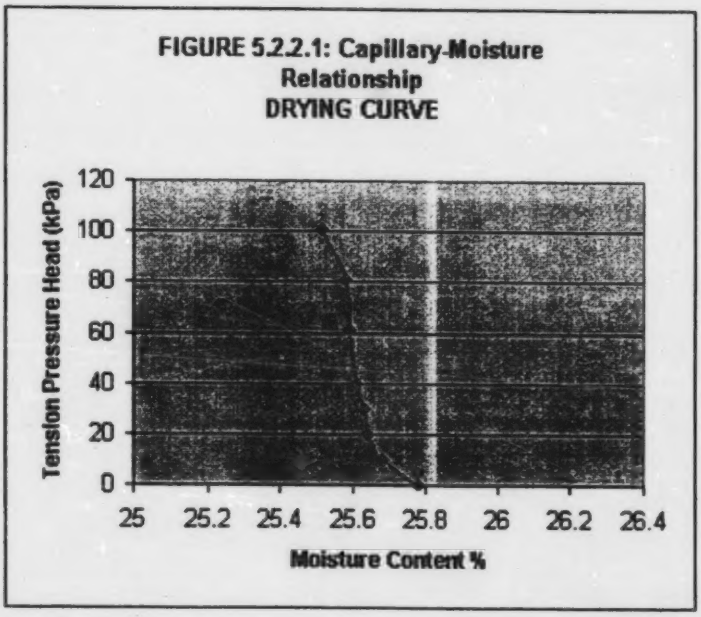
The significance of the capillary-moisture relationship as shown on Figure 5.2.2.1 is that the clayey silt cover material at 0.1 to 0.2 m below the surface of the cover did not exert a negative tension pressure head suggesting that at a moisture content of 25.8%, or 95% saturation, there is no matrix suction pressure. This means that the soil is at field capacity (fully saturated given the field conditions), and would drain if further moisture were added. This suggests that in an unsaturated environment, the maximum saturation of this material is 95% leaving 5% void space for air to occupy. Note that in Section 5.2.2 the moisture contents for samples obtained from 0.1 m at each of the testpit locations had moisture contents in the order of 26% at 0.2 m suggesting there is no matrix suction at this depth. Samples from 0.1 m at each of these locations have moisture contents below 25.8% and thus would be exerting negative matrix suction. Some of the moisture from this zone within the cover has likely been drawn out by capillary rise to the surface and subsequent evapouration. This illustrates that a protective cover less than 0.1 m in thickness would not be effective to retard oxygen diffusion. Analogously, thicknesses of silty clay greater than 0.1 m when wetted to field capacity would further decrease the amount of oxygen diffusion through the cover.

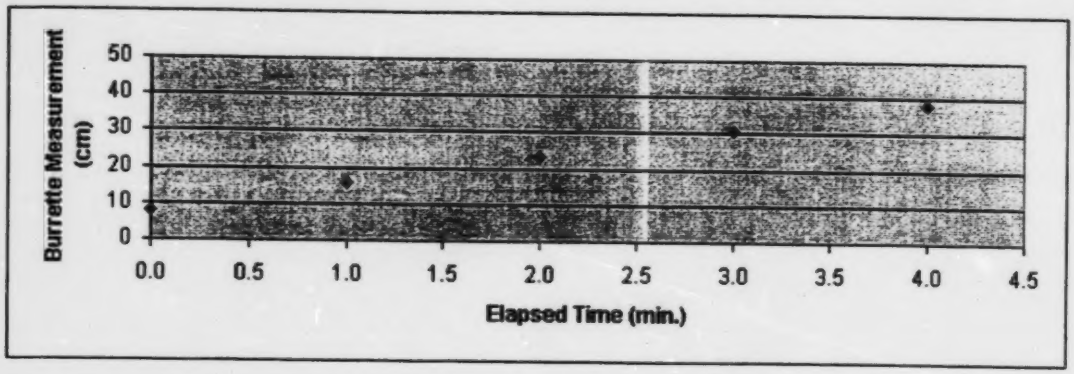
Figure 5.2.4.1: Graph showing Guelph Permeameter Results for GP1

Hydraulic Conductivity Calculation for GP 1

Kfs=(Ç*G*A*R1)/(a((Ç*H1)+1)+(G*Ç*3.14156*(a^2)))

Values:		
	Ç= Soil Texture/Structure Factor (cm^{-1})=	0.0100
	G = Dimensionless Shape Factor = 0.316(d/a)+0.184 =	0.3736
	A = Cross Sectional Area of Reservoir (Burrette) (cm^2) =	0.3850
	R1 = Steady rate of Water level fall in the reservoir (cm/s) =	**0.1250**
	a = Inside radius of infiltration surface (cm) =	10.0000
	H1 = Steady Pressure Head on the infiltration surface (cm) =	**27.0000**
	d = Depth of penetration of cutting ring into soil (cm) =	**6.0000**
	Kfs = Field Saturated Hydraulic Conductivity (cm/s) =	**1.30E-05**

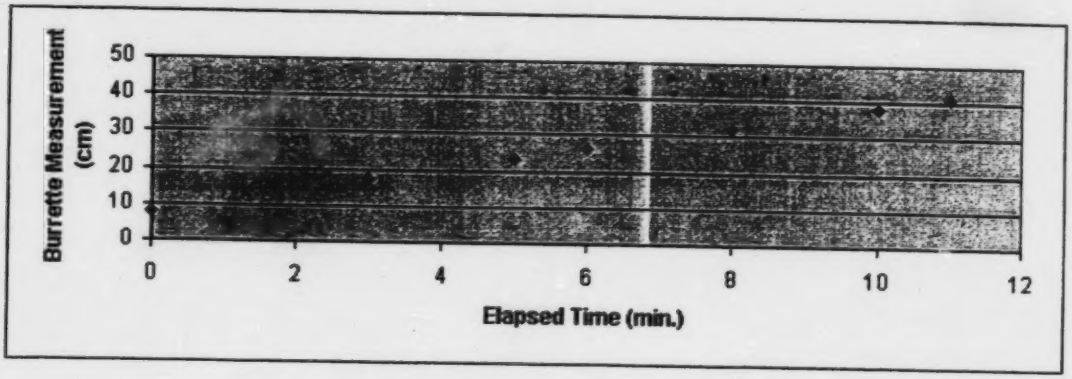
Figure 5.2.4.2: Guelph Permeameter Data for GP 2

Hydraulic Conductivity Calculation for GP 2

Kfs=(Ç*G*A*R1)/(a((Ç*H1)+1)+(G*Ç*3.14156*(a^2)))

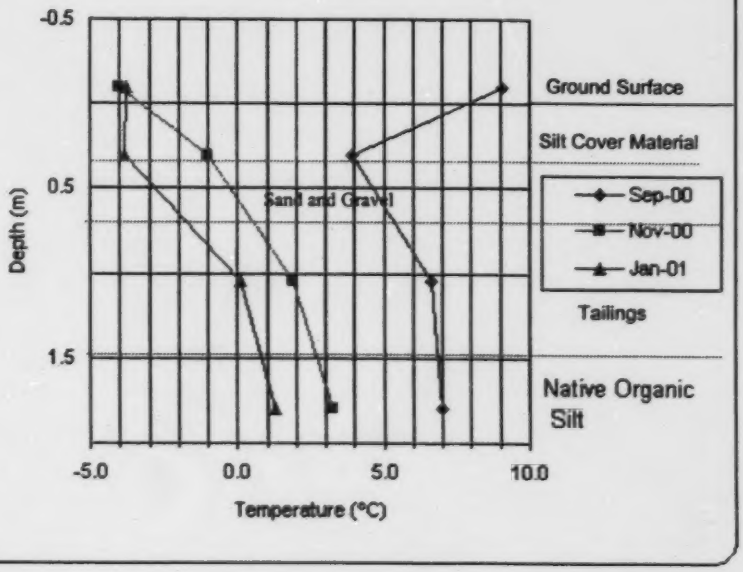
Figure 5.4.1: Temperature Profile

The following key observations are illustrated in Figure 5.4.1:

- The range of temperatures observed during each of the monitoring events did not fluctuate as much as did the ambient atmospheric temperatures, which suggests that the cover material has a moderating effect on the ground temperature within the tailings, resulting in cooler ground temperatures (in summer and fall) and hence less biological activity. This is consistent with the result reported by SRK for the tailings cover test facility at Faro.

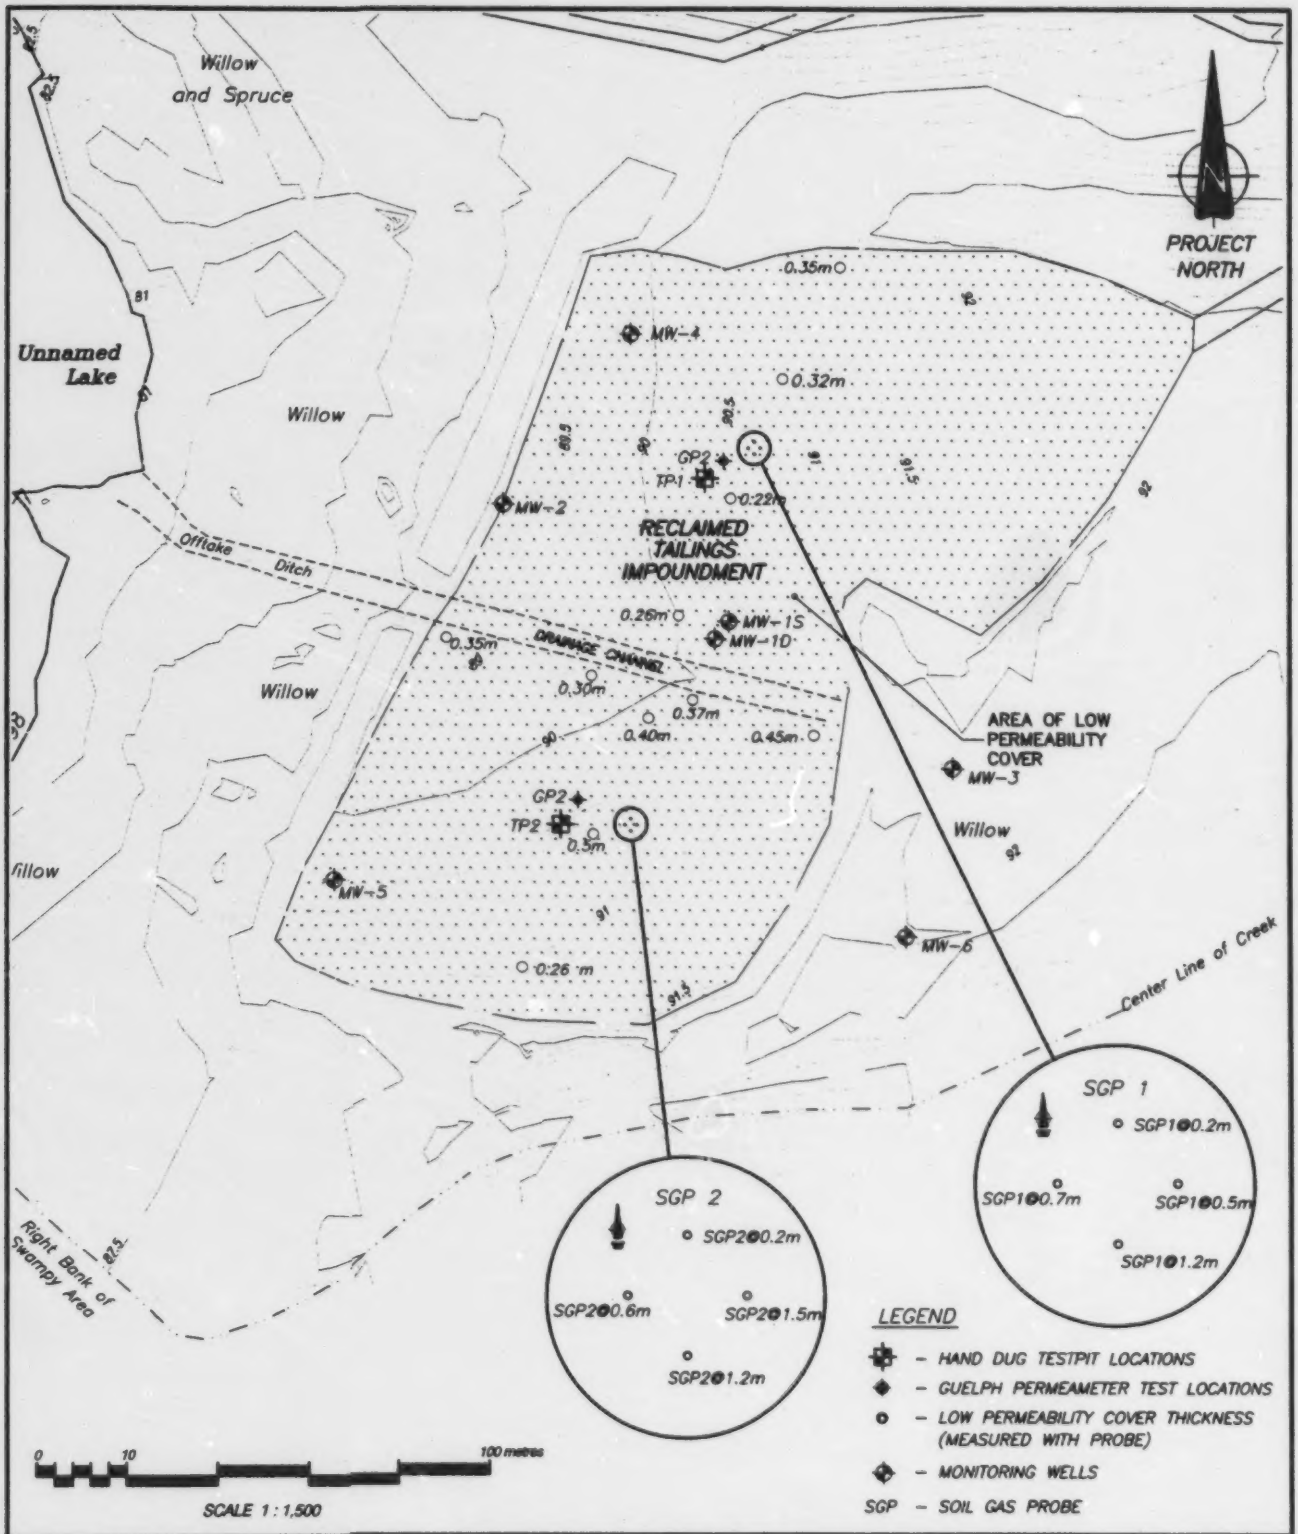
TITLE: SITE PLAN SHOWING SAMPLING LOCATIONS

The cover thicknesses obtained following the methodology in Section 4.3.4 are indicated on Figure 1 at the 12 locations that were probed. The cover thickness ranged from 0.22 m to 0.45 m with an average thickness of 0.35 m. The average cover thickness indicates that the as built cover thickness exceeds the specified thickness of 0.30 m and that at 8 locations out of 12 the cover thickness equalled or exceeded the design thickness of 0.3 m. Capillary moisture relationships as indicated in Section 5.2.2 illustrate that a cover material of 0.2 m in thickness or greater would be effective as an oxygen flux barrier. Thicknesses at each of the 12 locations exceed 0.2 m.

The tabulated data, and corresponding graphs and calculations for the data collected during the Guelph Permeameter tests at GP1 and GP2 (See Figure 1) are shown below.
